HPCM as a surface pavement Concept and properties

François de Larrard

LCPC Nantes - France

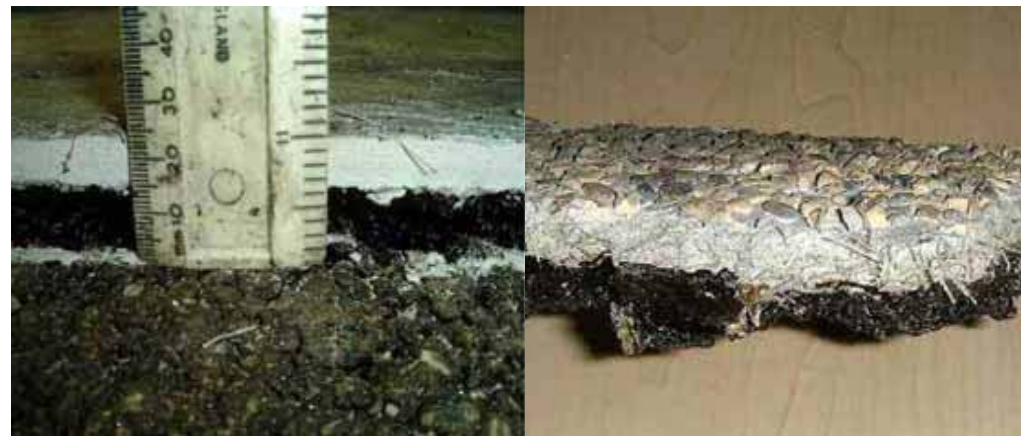
- « Ultra-ultra » thin white topping
- Main idea: best available mineral materials in minimum quantities

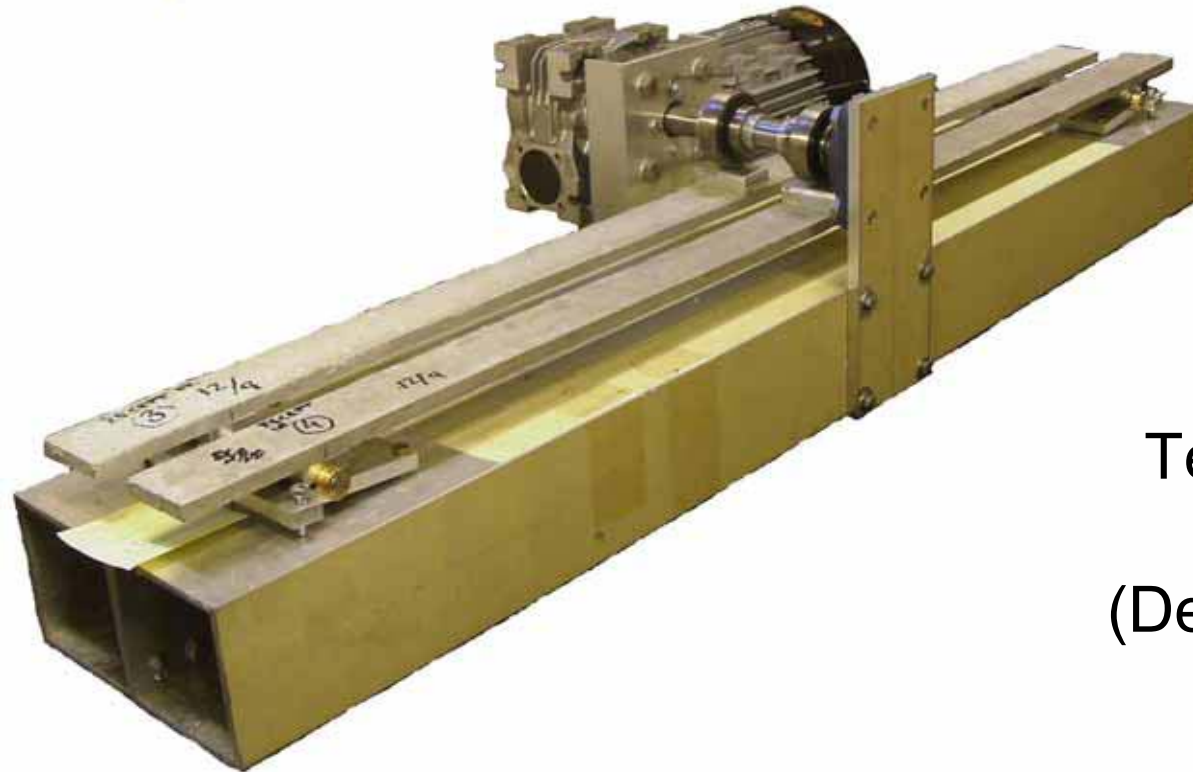
Tests at
DBT
(Denmark)

- Flexural fatigue behavior
 - tests on mortar reinforced with 2 % of either steel or PVA fibres
 - imposed deflection = 3 times the real one (under traffic loading)
 - 25 10^6 cycles
 - good behavior (decrease of E-modulus, but no failure)

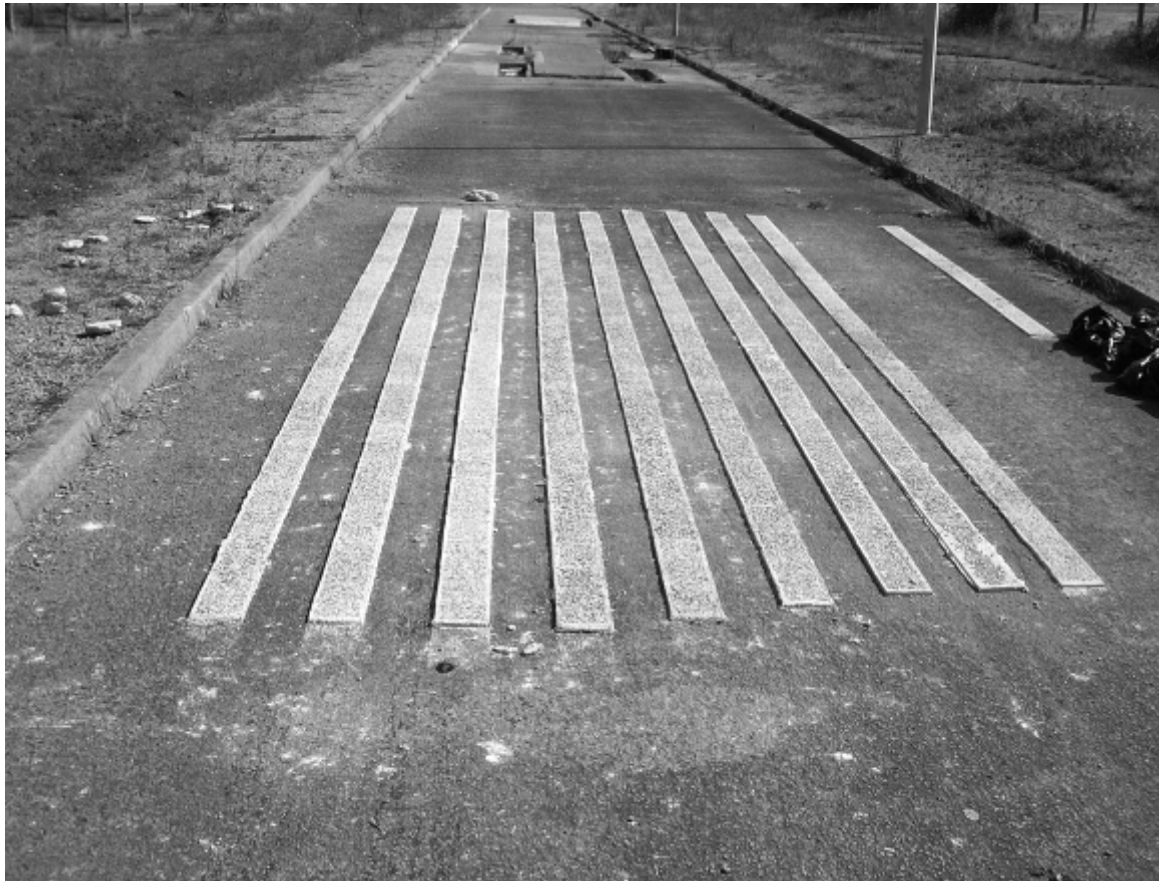
Tests at
LCPC
(France)

- Aim: to design the fibre reinforcement
- Two types of fibres
 - steel
 - PVA (Poly Vinyl Alcohol)
- Dosage: from 1 to 5 % in volume

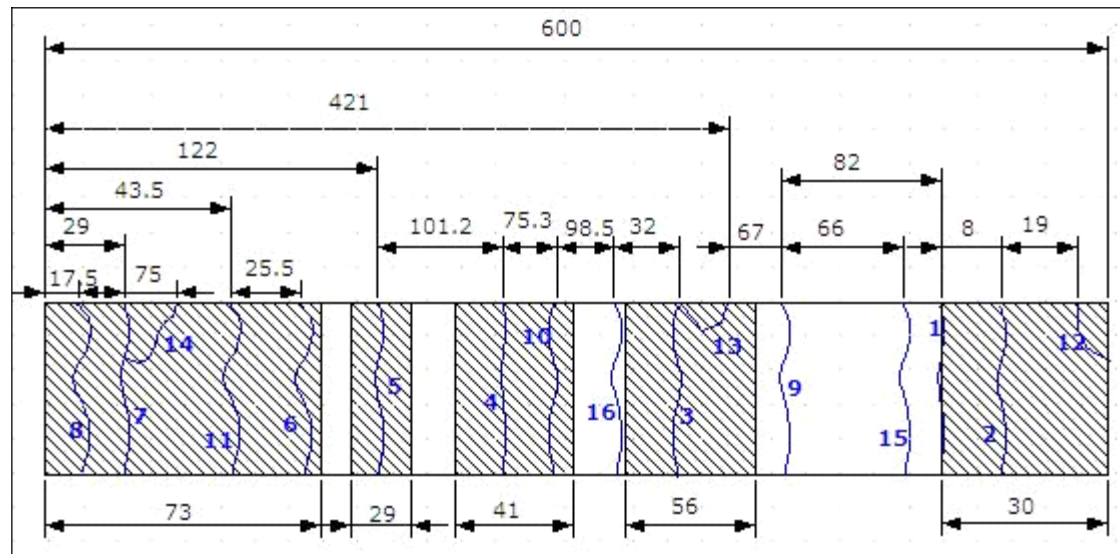
Results for plain mortar (no fibres)

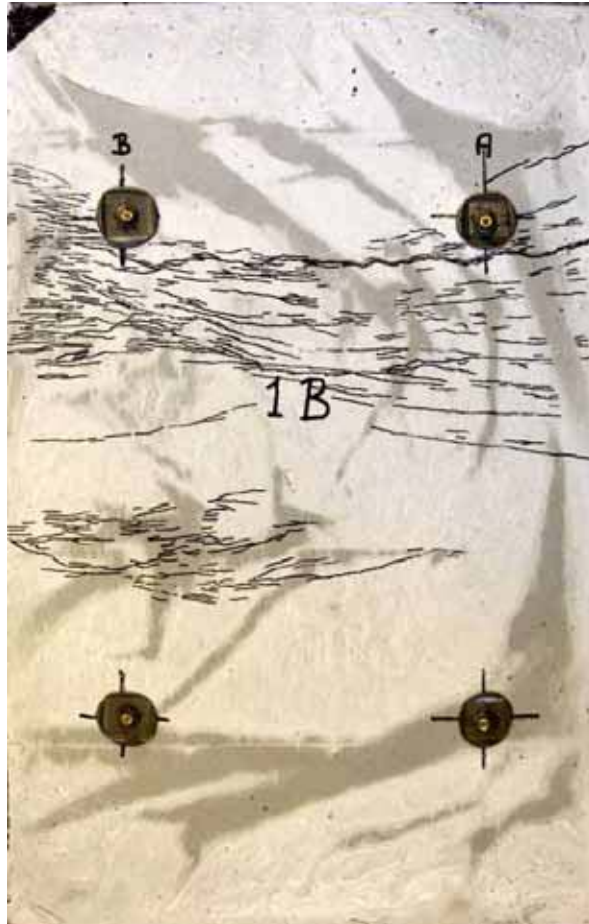
Tests at
DBT
(Denmark)

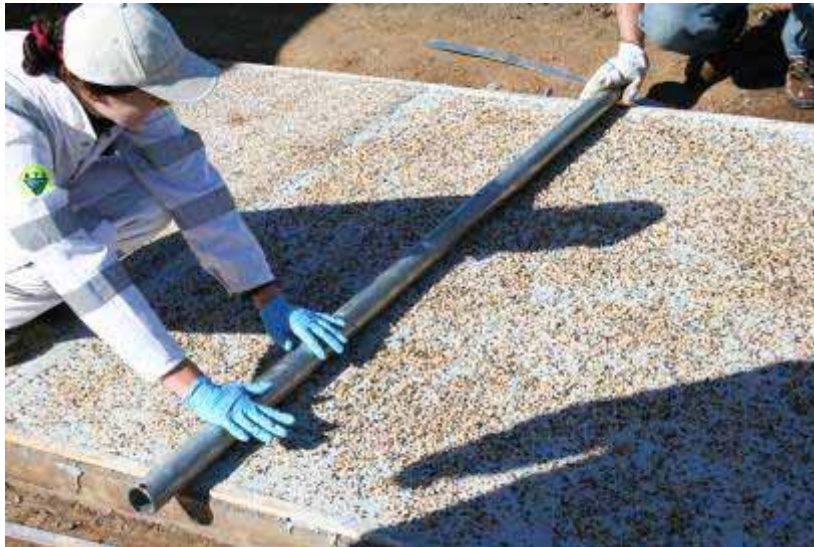
Tests at RTA (Australia)

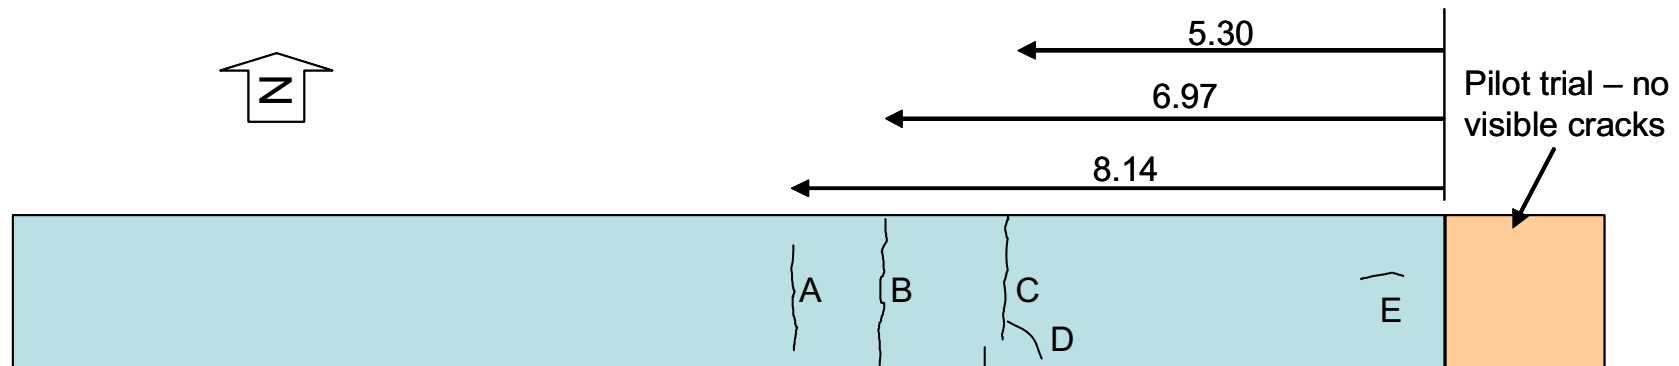
- Scale-1 test performed with 4 % of PVA fibres => cracking
- Better behavior with steel fibres
- With 3 % of SF, no visible cracks are likely to appear
- Stiff (asphalt) base course necessary

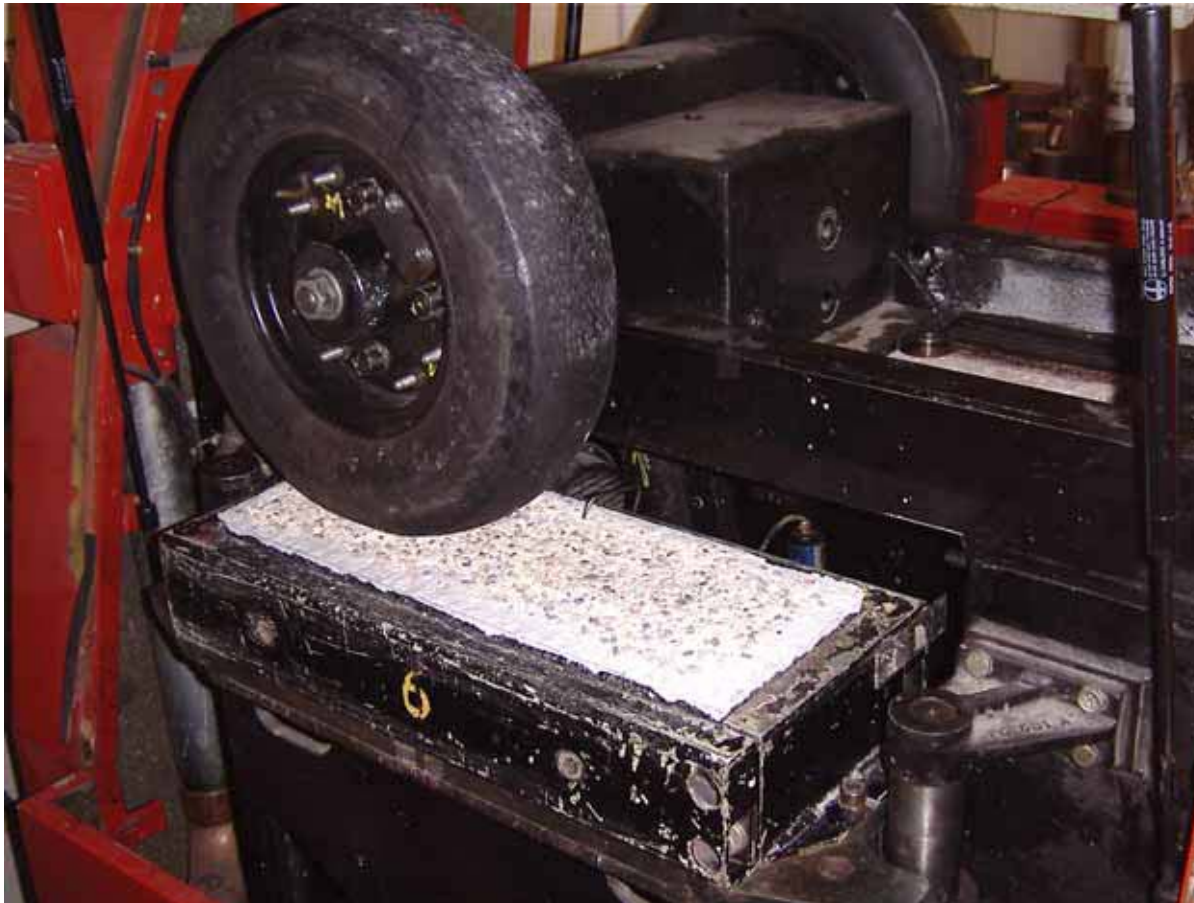
**The rutting
tester**

**LCPC
(France)**

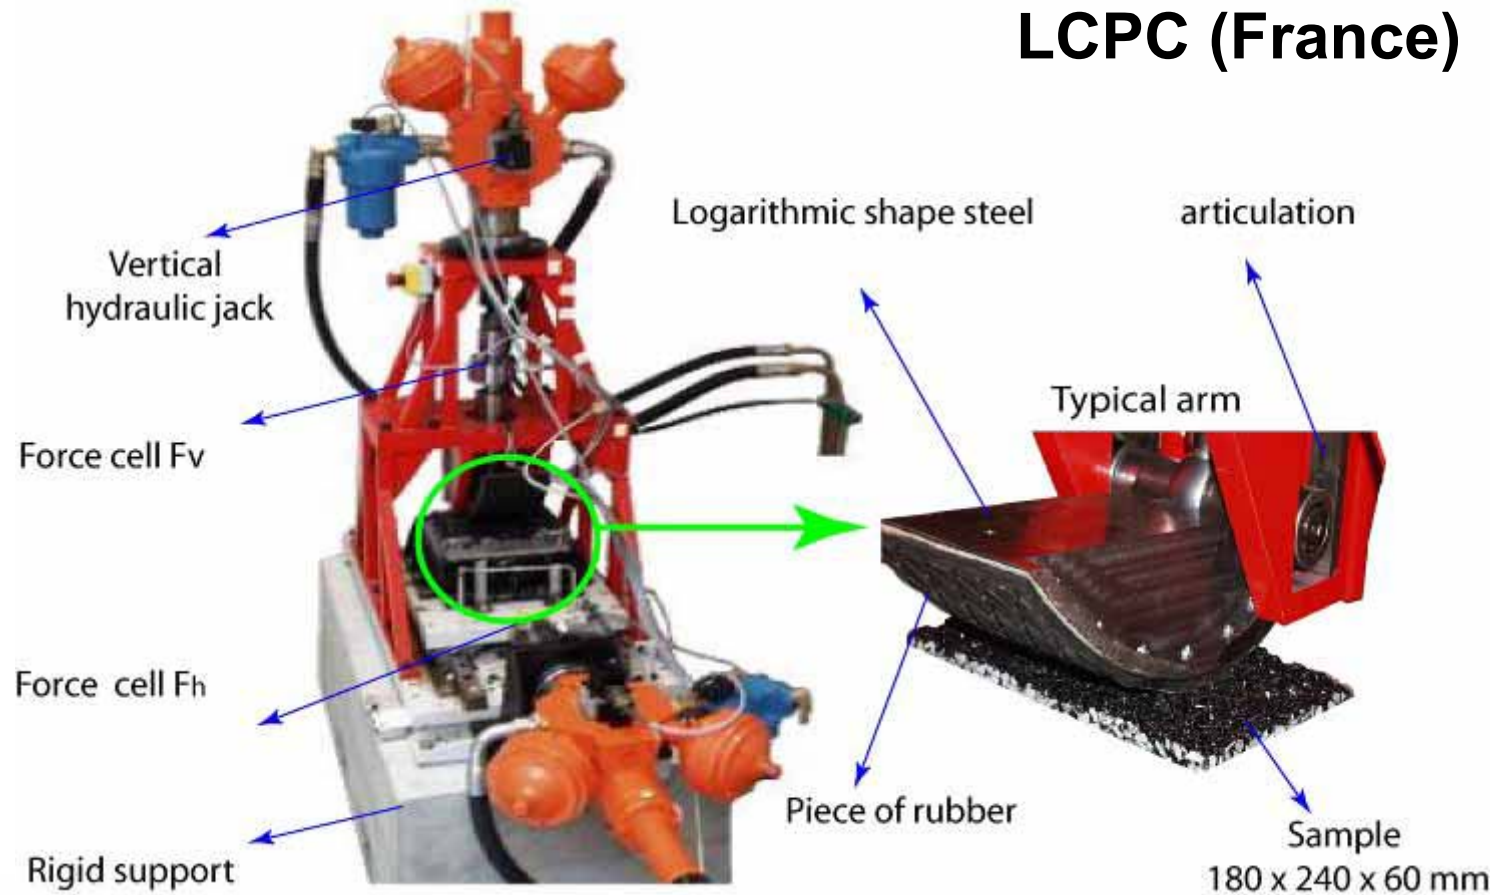
The « Tribometer » test LCPC (France)

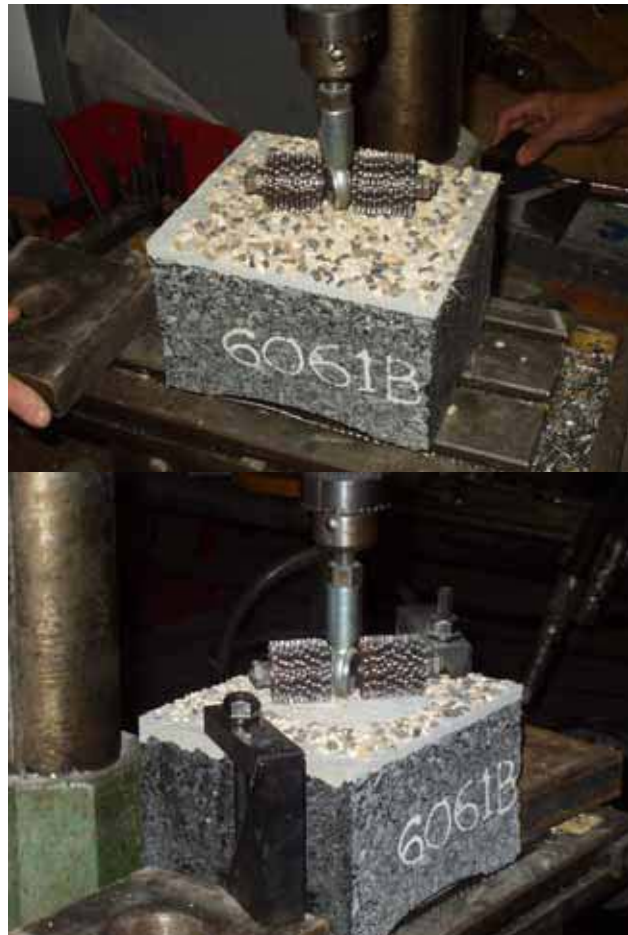
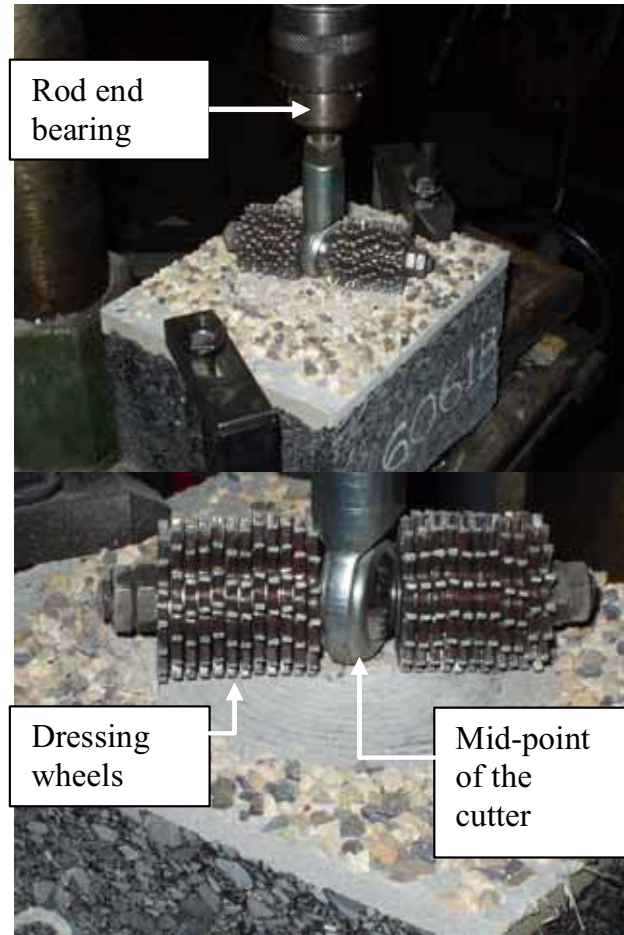
**Abrasion
test
FHWA
TFHRC
(USA)**

- Results:
 - excellent behavior under freeze/thaw
 - calcined bauxite => polishing not expected
 - limited loss of chippings likely to appear under traffic ($\approx 10\%$?) depending on the level of embedment
 - no influence on skid resistance

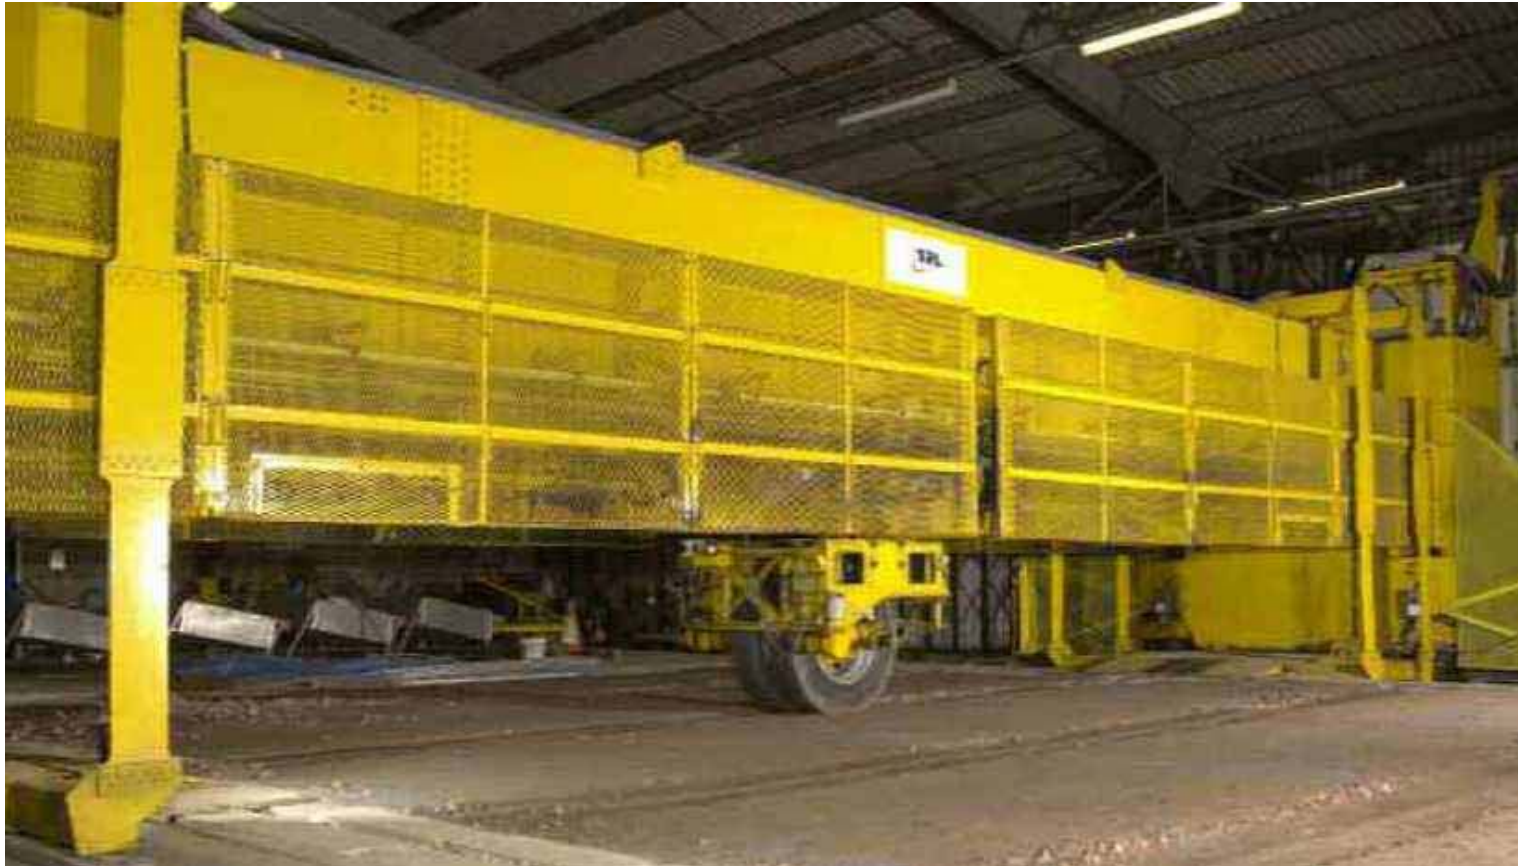
PTF test at TRL (UK)

- PTF Test
 - 1 M standard axle at 20°C
 - 0.5 M at 35°C
 - low rutting (1.5 mm instead of 8 mm for standard SMA)
 - delamination of asphalt at the edges => need for a stiff, low rutting asphalt
